AEP:NRC:3054-13 10 CFR 50.4

# Donald C. Cook Nuclear Plant Unit 2 UNIT 2 VESSEL HEAD INSPECTION RESULTS

# Westinghouse Report 1302426-03, Revision 1

# D. C. Cook Unit 2 U2-C14 Reactor Vessel Head Penetration Examination

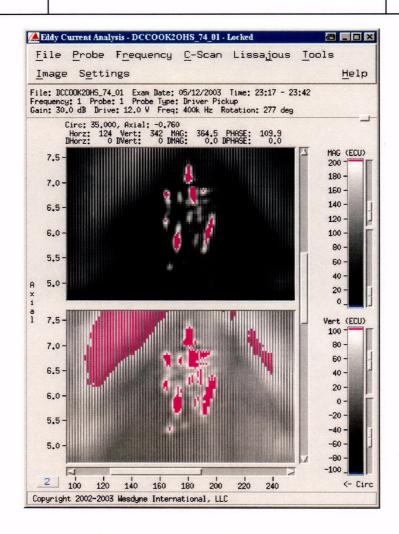
FIGURE 3 – EDDY CURRENT RESULTS PENETRATION #74 D.C. COOK UNIT 2

Results from the previous examination of penetration #74 in January 2002 showed the same condition existed at that time. An assessment of the eddy current characteristics of the condition in 2002 versus 2003 suggests there had been no extension during the recent operating cycle. Eddy current results, along with estimated individual crack lengths established by proximity rules are provided in figure 3. The depth of this cluster of indications was conservatively estimated by TOFD UT at 0.117". Additional details regarding the examination results and the comparison of the 2002 and 2003 eddy current data are found in Volume 2.

Indication #	Azimuth	Top End	Low End	Length
1	165°	6.96"	6.0"	0.96"
2	174°	6.92"	5.24"	1.68"
3	182°	7.52"	5.36"	2.16"
4	193°	7.04"	5.72"	1.32"
5	197°	6.6"	5.44"	1.16"

Results from the nondestructive examinations of the seventy-eight reactor vessel head penetrations, the vent line tube and vent line weld identified two reactor vessel penetration tubes, #43 and #74, with indications on the D surfaces that were repaired by electron discharge machining (EDM).

The EDM excavations in penetrations #74 and #43 were examined using a combination of eddy current from the ID surface and remote dye penetrant. The supplementary dye penetrant examination was necessary to examine small areas near the top and bottom of the excavations where the eddy current probe experienced liftoff. No indications were detected in the repair excavations.

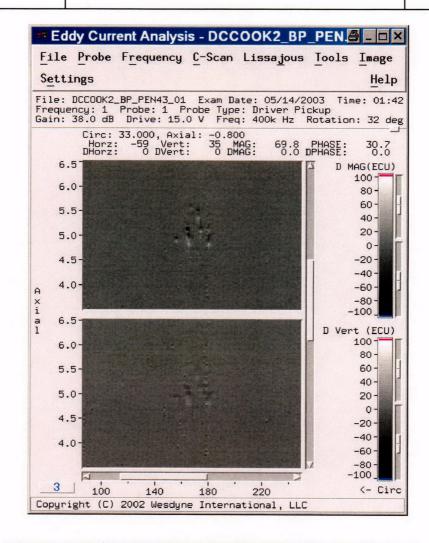
FIGURE 4 – EDDY CURRENT RESULTS PENETRATION #43 D.C. COOK UNIT 2

Eddy current results from penetration #43 are provided in figure 4. This cluster of indications is much smaller than that identified in penetration #74 and structural analysis predicts the condition will not grow to a structurally significant size during the next cycle, however it has been identified for repair as a conservative measure. No eddy current examinations were performed on this penetration during the January 2002 inspection program. Additional details regarding the examination results are found in Volume 2.

Indication #	Azimuth	Top End	Low End	Length	
1	156°	5.38"	5.22"	0.16"	
2	165°	5.62"	5.14"	0.48"	
3	172°	6.02"	5.42"	0.60"	
4	180°	5.70"	5.18"	0.52"
